DEPARTMENT OF TRANSPORTATION**DIVISION OF ENGINEERING SERVICES**

Office of Structural Materials

Contract #: 04-0120F4Cty: SF/ALA Rte: 80 PM: 13.2/13.9File #: 69.28**WELDING INSPECTION REPORT****Resident Engineer:** Pursell, Gary**Address:** 333 Burma Road**City:** Oakland, CA 94607**Report No:** WIR-003572**Date Inspected:** 03-Aug-2008**Project Name:** SAS Superstructure**OSM Arrival Time:** 630**Prime Contractor:** American Bridge/Fluor Enterprises, a JV**OSM Departure Time:** 1530**Contractor:** Zhenhua Port Machinery Company, Ltd (ZPMC), Changxing Island **Location:** Shanghai, China**CWI Name:** Fu Yu Hong**CWI Present:** Yes No**Inspected CWI report:** Yes No N/A**Rod Oven in Use:** Yes No N/A**Electrode to specification:** Yes No N/A**Weld Procedures Followed:** Yes No N/A**Qualified Welders:** Yes No N/A**Verified Joint Fit-up:** Yes No N/A**Approved Drawings:** Yes No N/A**Approved WPS:** Yes No N/A**Delayed / Cancelled:** Yes No N/A**Bridge No:** 34-0006**Component:** OBG**Summary of Items Observed:**

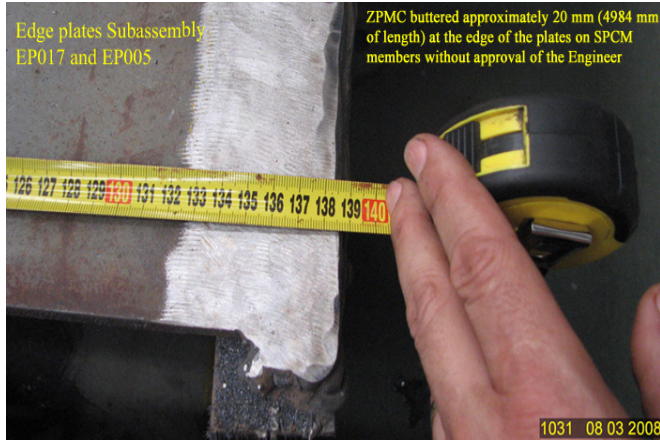
ZPMC performed approximately 20 mm buttering at the edge plates EP017B and EP005B on the SPCM member on the entire length (4984 mm) which exceeded the maximum allow of 4.5 mm (18 mm thick plate) as per section

12.17.2 for non critical repairs to correct length or weld geometric. The QA inspector had a conversation with ZPMC representative Zhan Jiadi Ken and ABF representative, Li Man Kit. The QA inspector brought to Mr. Zhan and Mr. Li attention that ZPMC performed approximately 20 mm buttering at the edge plates EP017B and EP005B on the seismic performance critical member (SPCM) without Engineer approval. The QA inspector added that the QA was going to recommend the issue of non conformance report regarding to this matter.
